PIC24FJ128GB204 Family Silicon Errata and Data Sheet Clarification

The PIC24FJ128GB204 family devices that you have received conform functionally to the current Device Data Sheet (DS30005009C), except for the anomalies described in this document.

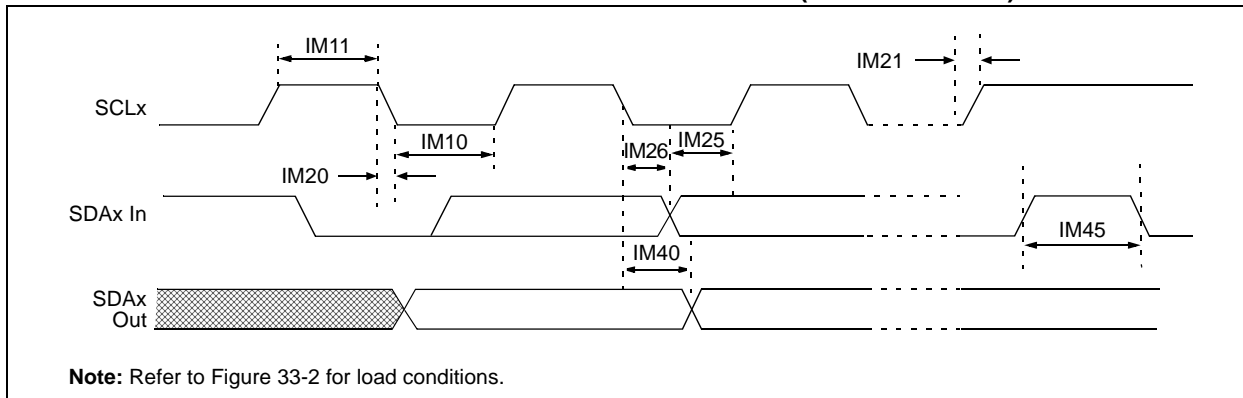
FIGURE 33-14: I²C BUS DATA TIMING CHARACTERISTICS (MASTER MODE)

Figure 33-14 and Figure 33-16 are modified as shown in the figures below.
